Australian Transport Safety Bureau

# Boiler Explosion at Geelong, Victoria— 17 May 2003

## *Medi Monaco*: Engineers burned by boiler explosions

April 2004

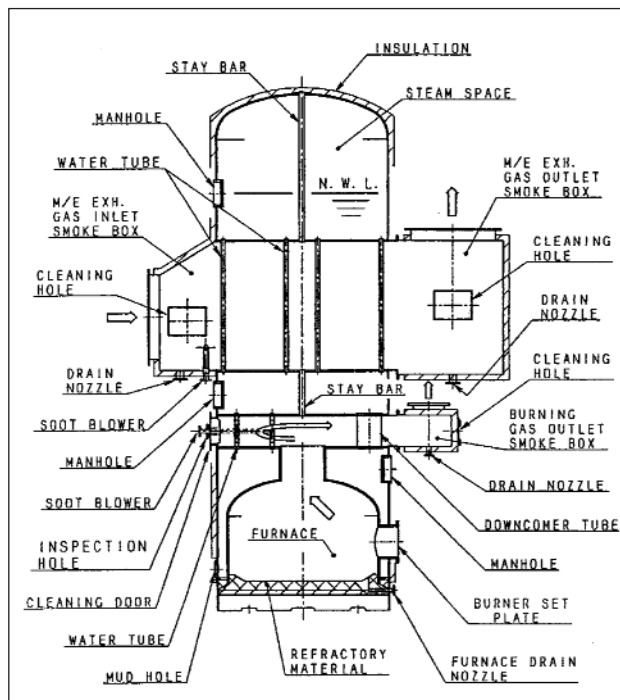
**FIGURE 2:**  
**Boiler schematic**

*Medi Monaco* is fitted with a vertical composite boiler (figure 2) manufactured in Japan by the Osaka Boiler Mfg Company (type OEVC2-100/95-18). The boiler has a working pressure of 5.9 bar and uses main engine exhaust gas and/or a packaged oil burner unit, burning heavy oil, to produce steam. The upper section of the water space in the boiler houses the economiser section, with main engine exhaust gas passing over a bank of boiler water tubes. Beneath the economiser section is the burner smoke box which has a hot gas inlet from the furnace, another bank of boiler water tubes, and an exhaust gas outlet. The truncated hemispherical steel furnace lies below the smoke box. The bottom of the furnace is lined with refractory and it has a circular opening on one side to accept the oil burner unit.

The boiler furnace design contributed to the incident on *Medi Monaco*. The furnace floor was not water-cooled (many auxiliary boiler designs have a water space around the entire furnace) and is lined with refractory which

cools relatively slowly after the boiler has been firing. In addition, the locations of the burner opening and the smoke box inlet make the furnace prone to the accumulation of pockets of unswept gas.

The furnace chamber has a single burner opening at the side and a single outlet at the top leading to the smoke box. When the burner is running, the flame is directed at the furnace wall opposite the burner opening with the flow of hot gas sweeping the periphery of the cylindrical furnace chamber before rising to the smoke box inlet. When the burner is stopped, there is no flow of air through the furnace until the maintenance cover on the burner is opened. With the maintenance cover removed, the airflow through the furnace depends on the pressure differential between the engine room and the uptakes, and increases, due to natural updraught, when the furnace and boiler uptake is hot. At this time, the airflow is limited and would tend to pass directly from the burner opening to the smoke box inlet, leaving areas adjacent to the furnace walls relatively unswept.

The unsuccessful attempts to relight the burner deposited a mix of heavy fuel and diesel on the furnace floor and on the wall opposite the burner opening. The residual heat in the refractory lining and furnace walls in this area was sufficient to vaporise this fuel mix with its relatively low flashpoint. When the third engineer removed the maintenance cover, the air draught through the oil burning unit was insufficient to purge the whole furnace and bypassed this relatively still, hot, area of the furnace. Thus the fuel vapour accumulated until it was rich enough to ignite, causing the first flashback. The succeeding flashbacks were caused in the same way i.e. the fuel vapour concentration increased until it reached the point where it was ignited either by the hot refractory or the small, self-sustaining, fire (probably started by the first explosion) on the furnace floor, as described by the chief engineer. The explosions

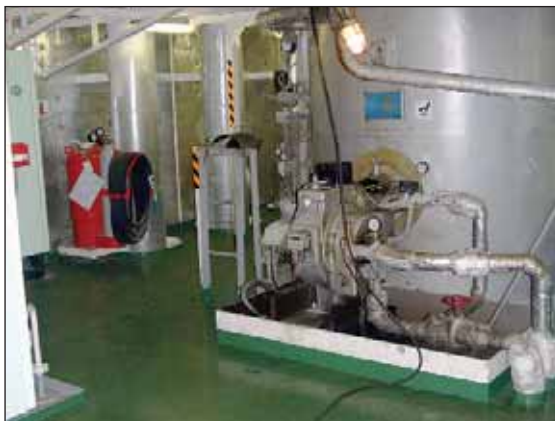
**FIGURE 3:**  
**Oil burner unit**

When the main engine is stopped, or is providing insufficient exhaust gas energy to supply the steam demand, *Medi Monaco's* boiler is fired using oil. The oil firing unit is a Volcano VJ-90-1, fully automatic, pressure jet oil burner manufactured by the Volcano Company of Japan (figures 3 and 4). The oil burner is fully integrated with a single electric motor driving both the forced draft fan and the fuel feed pump. Air control is provided by a single two-position damper on the fan's air inlet housing. The burner, which may be fired using either diesel or heavy fuel, has an integrated electric heater for use when firing on heavy fuel. The burner controls and monitoring system are located in a panel adjacent to the burner unit.

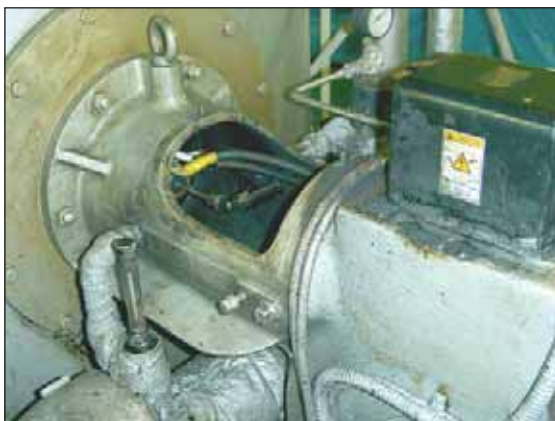
**FIGURE 4:**  
**Oil burner maintenance opening**

At that moment, as he was bending over the burner unit, there was an explosion, or flashback, from the boiler furnace. The third engineer's face and upper body were sprayed with burning fuel which had been blown out of the maintenance opening at the top of the burner unit. The third engineer knew that he had been badly burned and ran to wash his face, before going quickly to the upper deck to get assistance.

*Medi Monaco's* engineers were routinely opening the burner maintenance cover immediately after several attempts to relight the burner and often while the furnace was still hot. Although there was no ship-specific

written procedure for servicing the burner, the burner instruction manual did contain guidance and appropriate warnings for the task. It stipulates that the furnace must be purged with the fan for a minimum of 60 seconds after each flame failure before looking into the cause. Sufficient purging of the boiler furnace prior to opening the burner unit is a basic safety precaution, however in some cases it may not be enough to prevent a flashback. If a number of attempts have been made to relight the burner there may be liquid fuel lying in the furnace even after lengthy purging. At these times it is crucial to let the furnace cool sufficiently before it is opened. On *Medi Monaco* there was no easy way to gauge when to take this precaution as the boiler was not equipped with a quick method of safely sighting the furnace floor. The complete burner unit had to be withdrawn to allow the furnace to be inspected.

Each time *Medi Monaco's* engineers hurriedly opened the burner maintenance cover, without purging or allowing the furnace to cool, they ran the risk of a boiler flashback and the consequent danger of injury.

The Osaka Boiler Mfg Company provide a safety bulletin to operators of OEVC2 boilers warning them of the incidents on *Medi Monaco* and *Alam Mesra* and drawing their attention to the correct safety precautions when servicing the fuel burner unit.

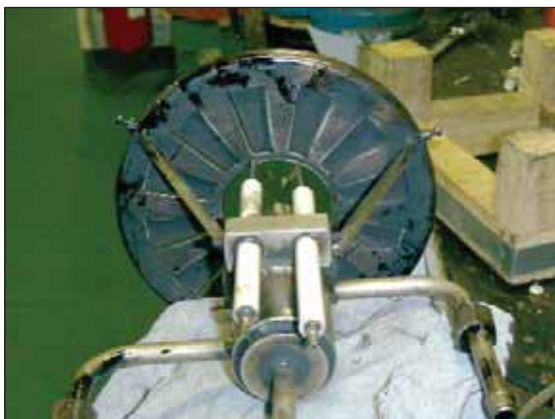
**FIGURE 5:**  
**Burner head assembly**

The burner head assembly (figure 5) is fitted inside the 'flame funnel' at the boiler furnace opening. It consists of a single nozzle attached to the 'atomiser block', the flame 'stabilisation ring' (air swirling disk) and ignition electrodes. The atomiser block has three fuel connections, one line which is led from an electric solenoid valve which feeds the fuel nozzle, and two other lines which allow fuel circulation

through the atomiser block. The burner head assembly may be easily removed from the burner unit via a maintenance cover at the top of the burner after the igniter electrode leads and the three fuel pipes attached to the atomiser block are disconnected.

Generally, the burner services performed by *Medi Monaco's* engineers prior to the incident involved stopping the burner and removing the burner head assembly from the unit to clean carbon residue from the flame stabilisation disc and igniter electrodes. Each service was taking up to 30 minutes. During the time the burner was being serviced, the boiler steam pressure would fall continuously. The falling boiler pressure was often causing alarms and problems with other equipment using the boiler steam, particularly the purifiers and the generator fuel system. As a result, the engineers were under considerable pressure to complete the burner service as quickly as possible in order to minimise the loss of steam pressure.
